SAMPLE REPORT

The Water Prospector
Ground Water Survey

Example of a Survey Report
(Clients name here)

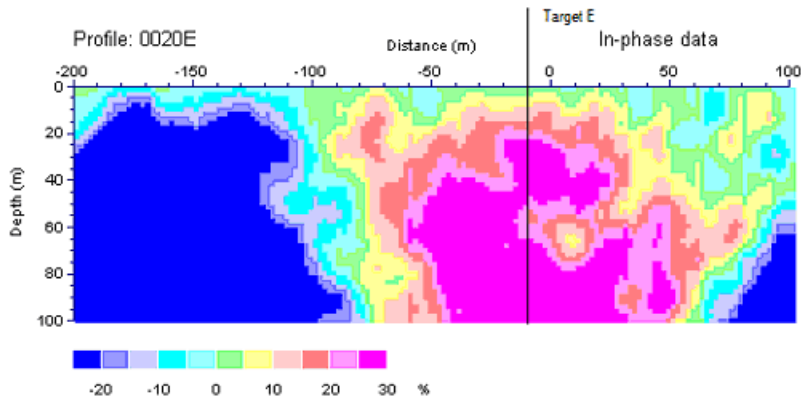
Target #E 0020 @ -10 meters

The porous area of the fracture measures over 80 meters (264 feet) in width. The density level is 30%. The approx depth to the bottom of the fracture. 130 meters (429 feet).

Reference: scan 0020E -10m

GPS N09deg 87.862' W085deg 40.602' A ground marker has been placed at this site.

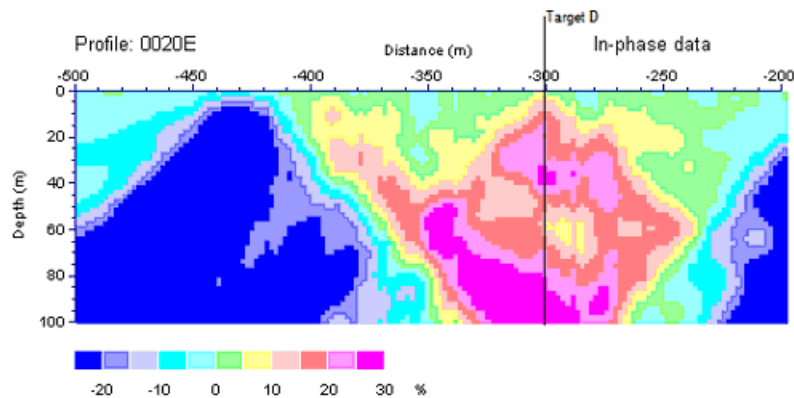
Target #D 0020 @ -300 meters

The porous area of the fracture measures over 60 meters (198 feet) in width. The density level is 30%. The approx depth to the bottom of the fracture. 120 meters (396 feet).

Reference: scan 0220E 10m

GPS N09deg 87.556' W085deg 40.031' A ground marker has been placed at this site.

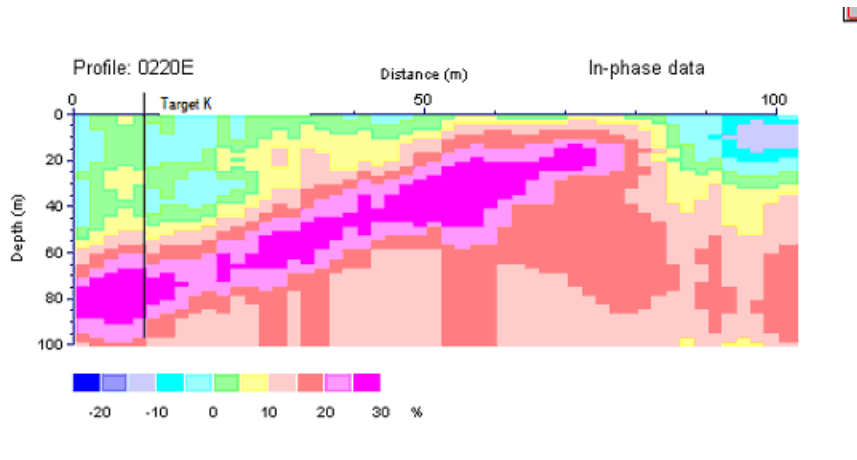
Target #K 0220 @ 10 meters

The porous area of the fracture measures over 70 meters (231 feet) in width. The density level is 30%.
The approx depth to the bottom of the fracture. 90 meters (297 feet).

Reference: scan 0220E 10m

GPS N09deg 87.556' W085deg 40.031' A ground marker has been placed at this site.

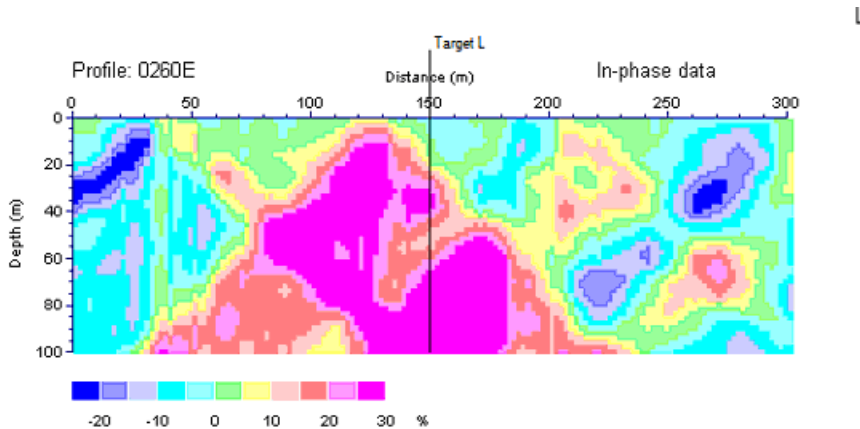
Target #L 0260 @ 150 meters

The porous area of the fracture measures over 70 meters (231 feet) in width. The density level is 30%.
The approx depth to the bottom of the fracture. 120 meters (396 feet).

Reference: scan 0260E 150m

GPS N09deg 88.064' W085deg 40.020' A ground marker has been placed at this site.

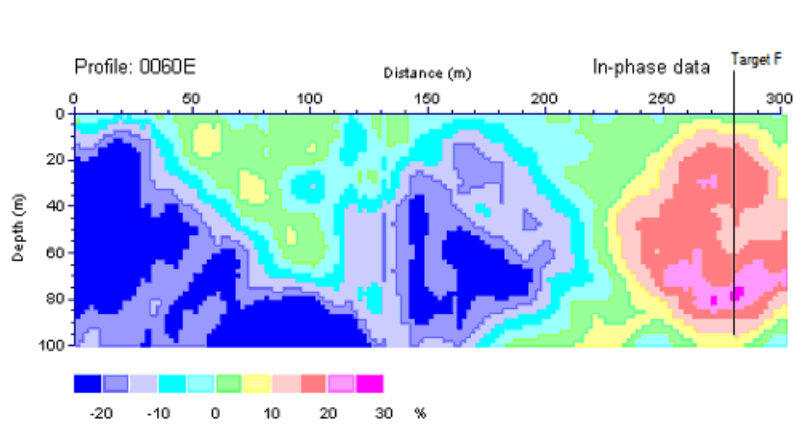
Target #F 0060 @ 280 meters

The porous area of the fracture measures over 40 meters (132 feet) in width. The density level is 30%.

The approx depth to the bottom of the fracture. 90 meters (296 feet).

Reference: scan 0060E 280m

GPS N09deg 86.774' W085deg 41.165' A ground marker has been placed at this site.

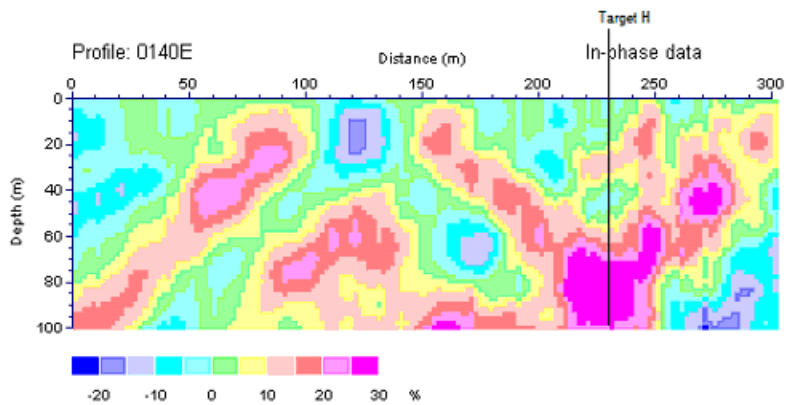
Target #H 0140 @ 230 meters

The porous area of the fracture measures over 30 meters (99 feet) in width. The density level is 30%.

The approx depth to the bottom of the fracture. 100 meters (330 feet).

Reference: scan 0140E 230m

GPS N09deg 87.595' W085deg 40.108' A ground marker has been placed at this site.

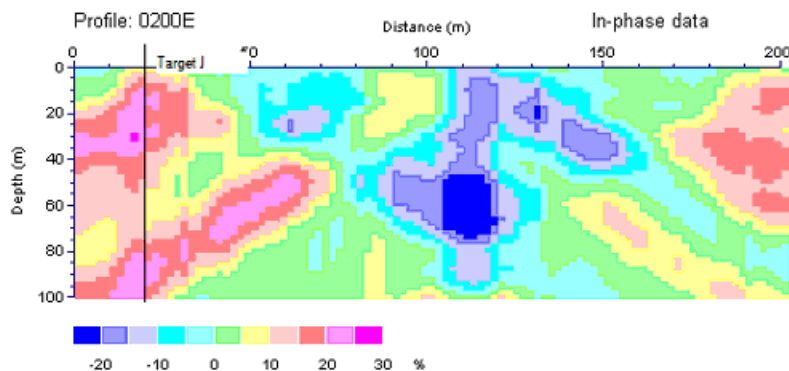
Target #J 0200 @ 20 meters

The porous area of the fracture measures over 60 meters (199 feet) in width. The density level is 25%.

The approx depth to the bottom of the fracture. 110 meters (363 feet).

Reference: scan 0200E 20m

GPS N09deg 87.280' W085deg 40.090' A ground marker has been placed at this site.
